FLOOD PLAIN INFORMATION

ONTONAGON RIVER ONTONAGON, MICHIGAN

LAKE SUPERIOR SHORELINE ONTONAGON COUNTY, MICHIGAN

PREPARED IN COOPERATION
with
WATER RESOURCES COMMISSION
MICHIGAN DEPARTMENT OF NATURAL RESOURCES
THE VILLAGE OF ONTONAGON
and
ONTONAGON COUNTY
by
DEPARTMENT OF THE ARMY
ST. PAUL DISTRICT CORPS OF ENGINEERS
ST. PAUL, MINNESOTA
SEPTEMBER 1970

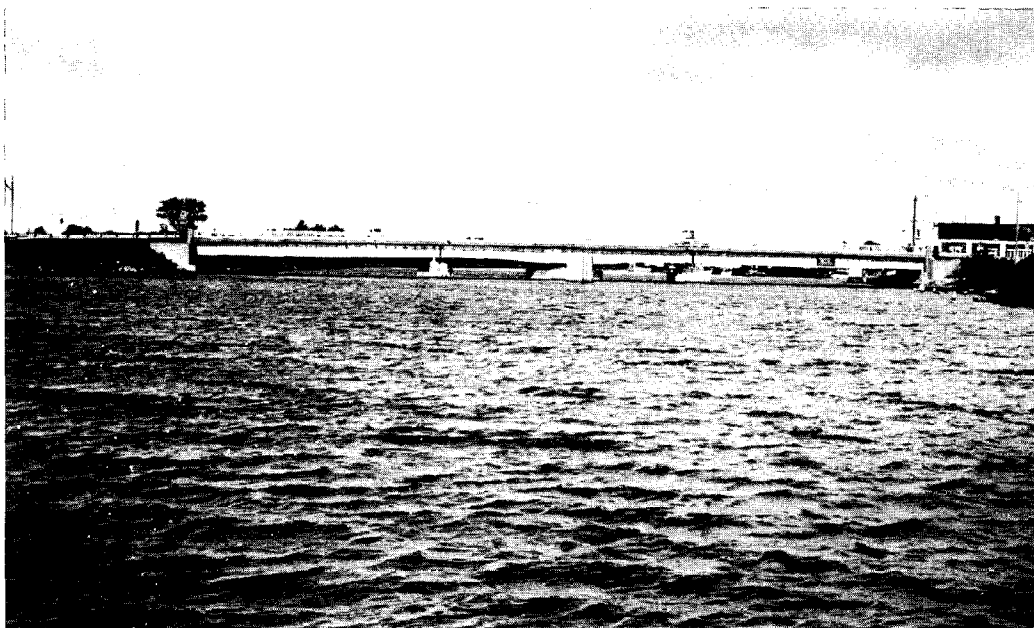
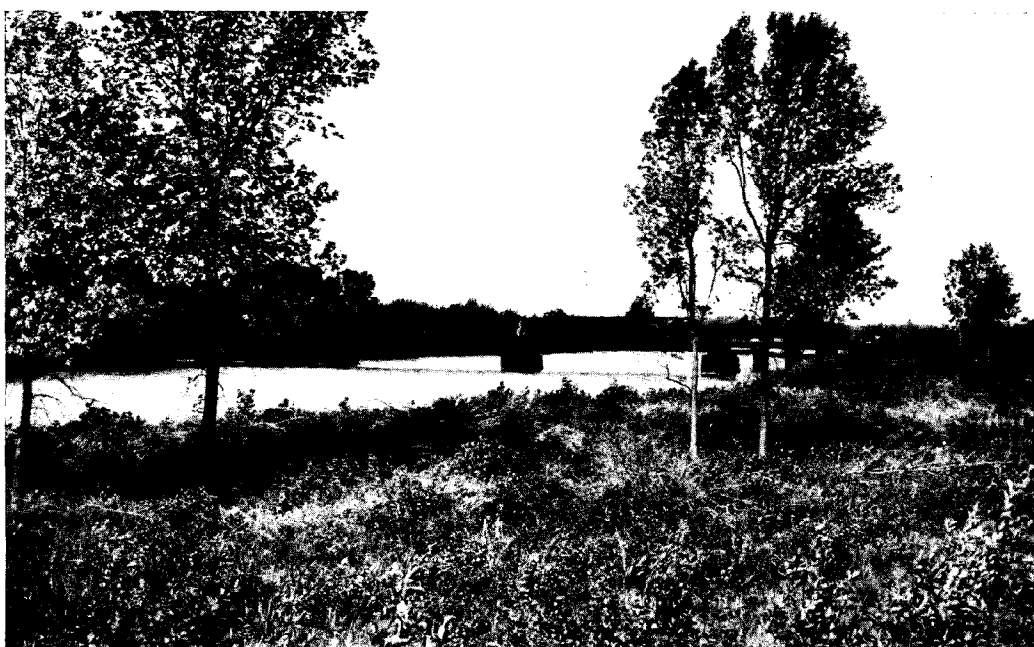
Figure 3. -- ONTONAGON RIVER BRIDGES

Upper view is upstream side of State Highway 64 Bridge over the Ontonagon River at Mile 0.66. Lower view is upstream side of C.M.St.P.&P. Railroad Bridge over the Ontonagon River at Mile 1.08.

Within the reach covered by this study, there are two bridges across the Ontonagon River. Table 3 lists pertinent elevations for the structures and shows their relation to the crest of the flood of April 1, 1963, and the Intermediate Regional Flood. Figure 3 shows photographs of these bridges.

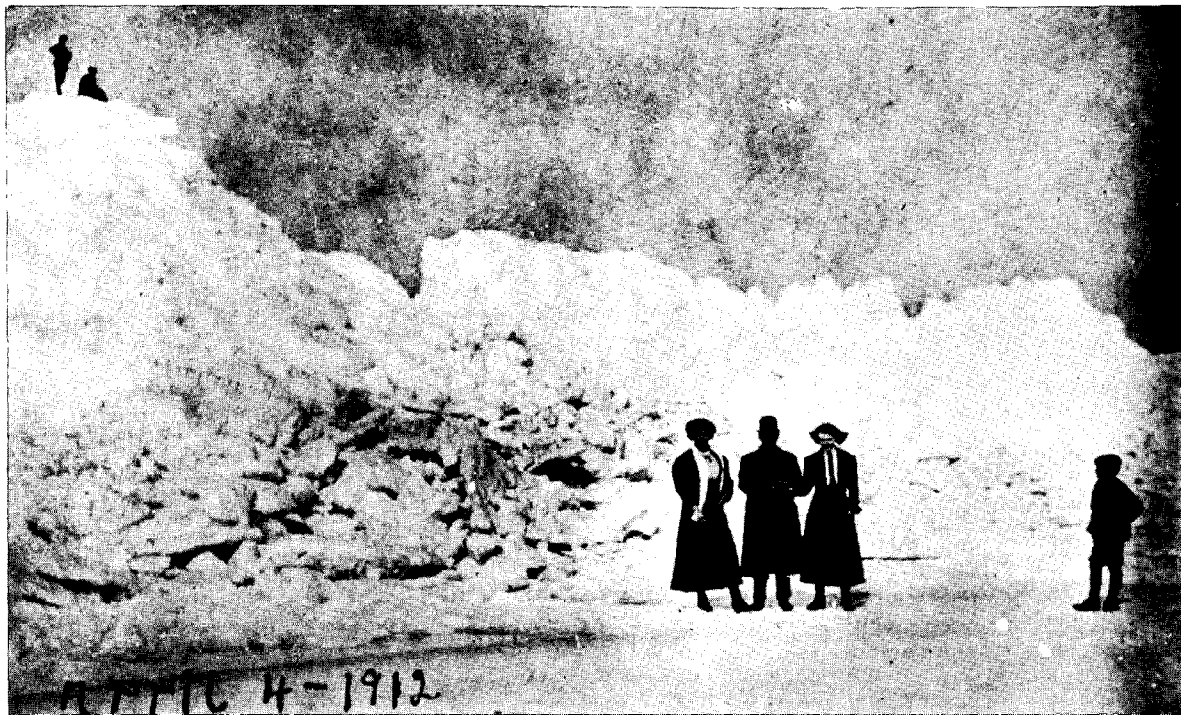
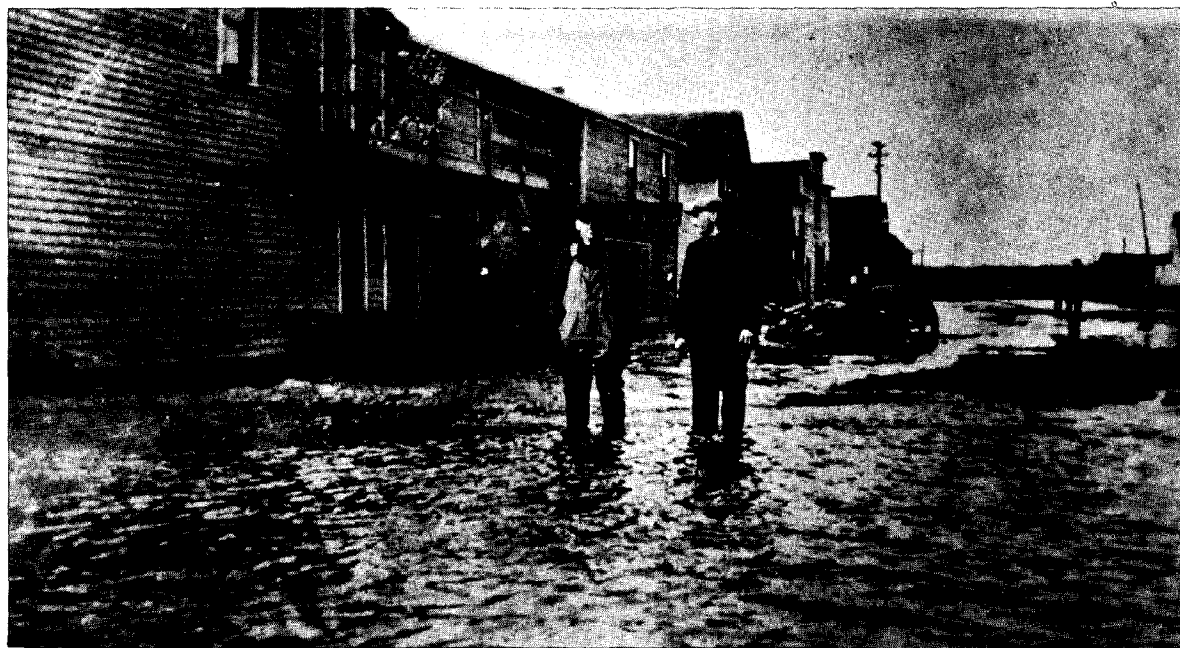
Figure 4. -- FLOOD SCENES IN ONTONAGON - APRIL 1912

Top view was taken near the mouth of the Ontonagon River where winds from Lake Superior had caused windrows estimated to be 60 feet in height. The windrows sealed off the mouth of the Ontonagon River causing the flood of 1912. Lower view is looking along River Street in Ontonagon during the April 1912 flood.

Few details are available regarding the stage and discharge during the 1912 flood. Photographs showing the cause and effect of the flood are presented on Figure 4.

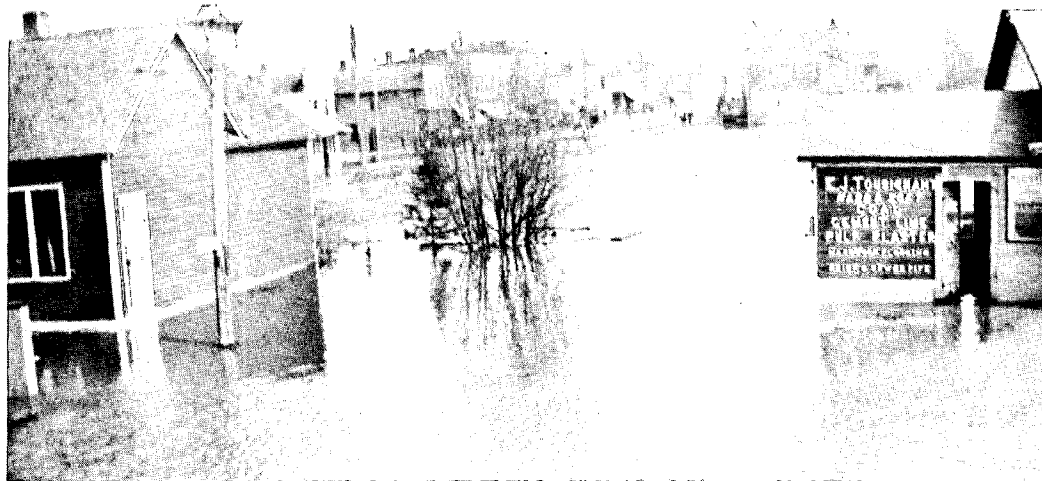
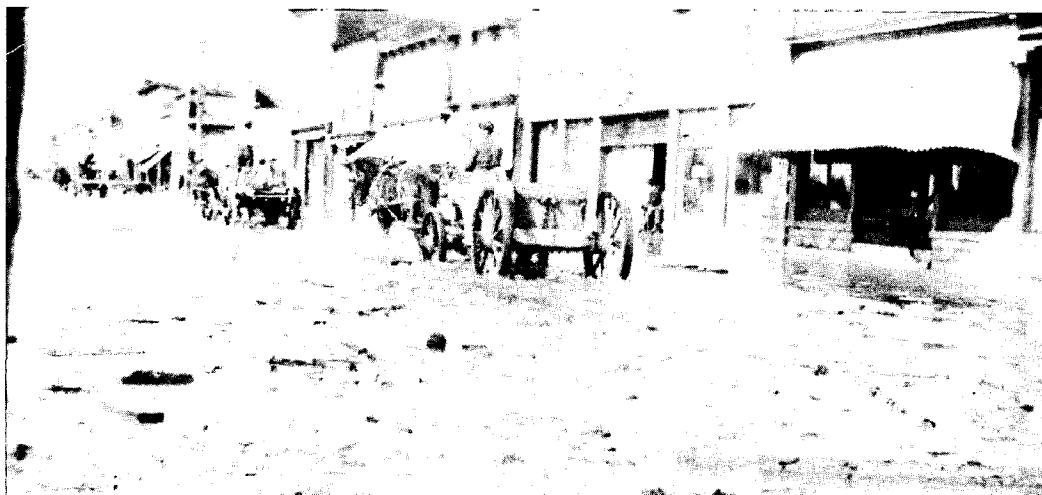
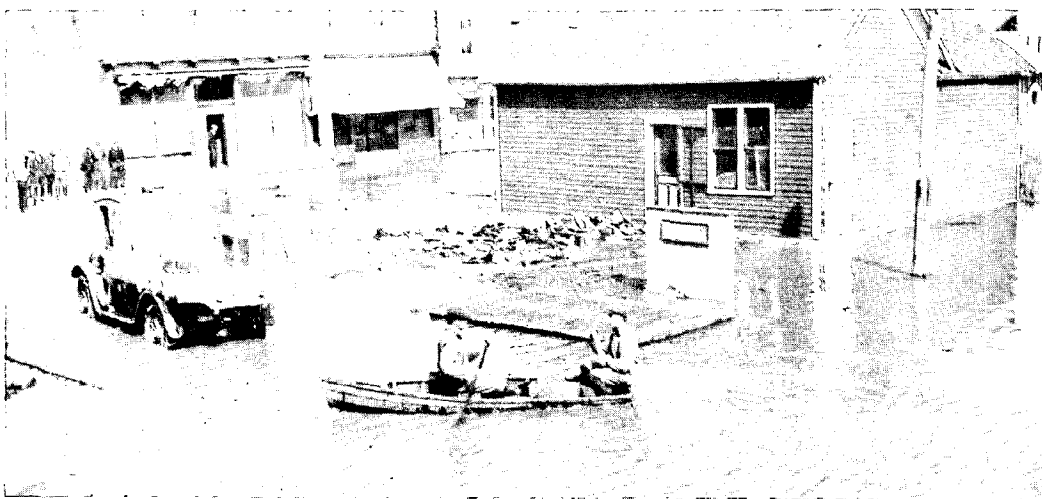
Figure 5. -- FLOOD SCENES IN ONTONAGON - MAY 1922

These photographs which were taken in the downtown portion of Ontonagon show the severity of the May 1922 flood.

Photographs have been obtained which show flood conditions in Ontonagon in May 1922. No other records pertaining to this flood have been discovered. Three of the photographs are included as Figure 5.

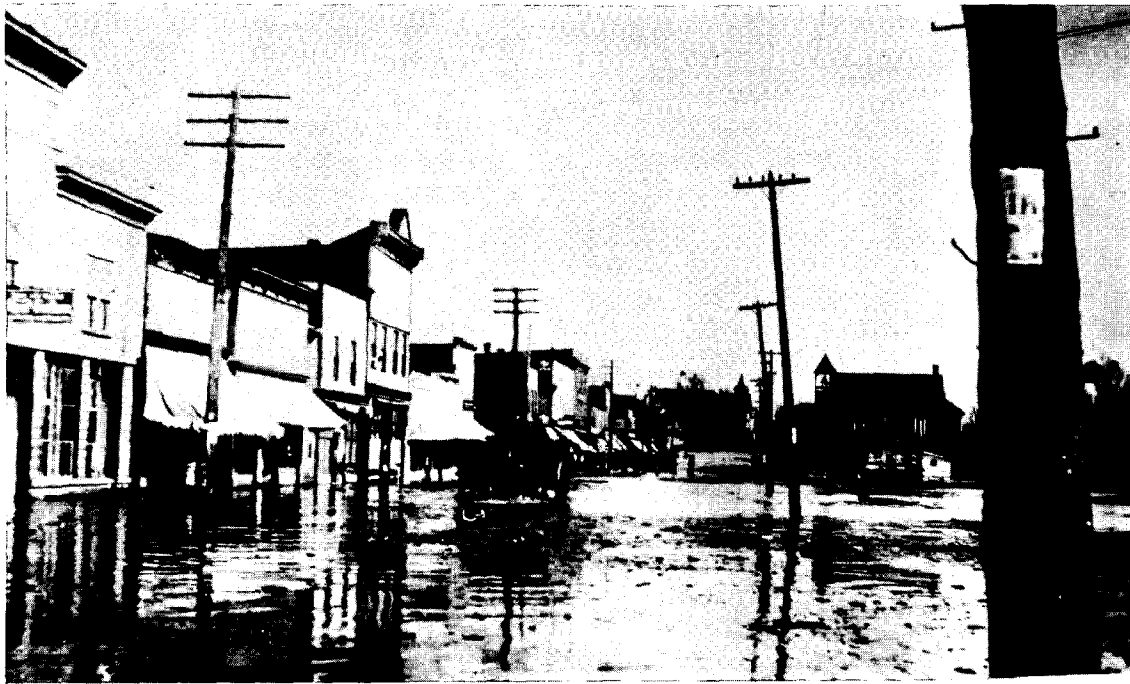
Figure 6. -- FLOOD SCENE IN ONTONAGON - APRIL 1923

This view shows a horse drawn wagon coming down River Street during the 1923 flood.

The flood of April 1923 was caused by spring snow melt and large ice jams at the mouth of the Ontonagon River. A photograph of River Street during this flood is shown on Figure 6.

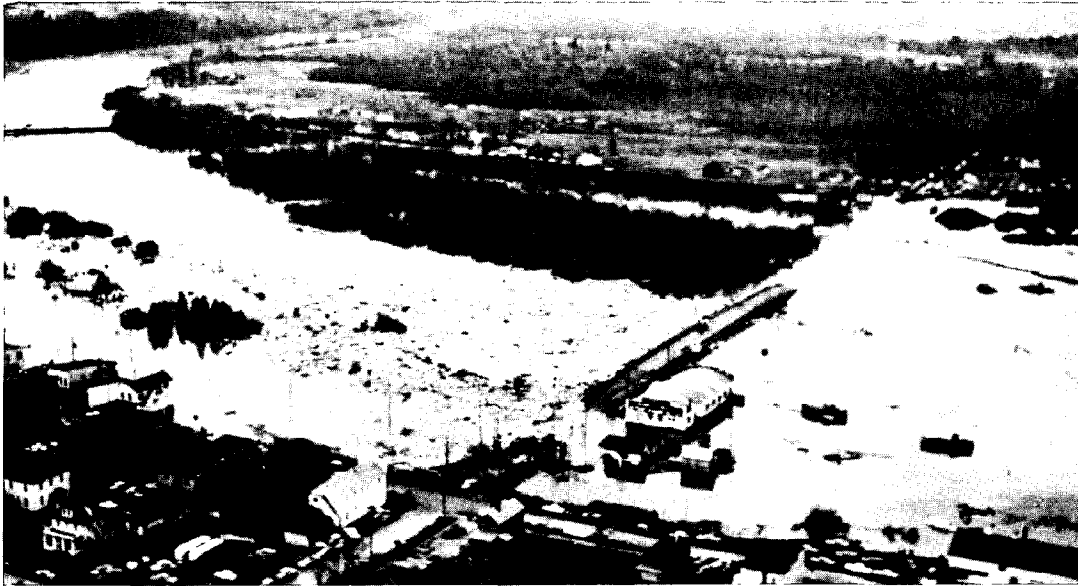
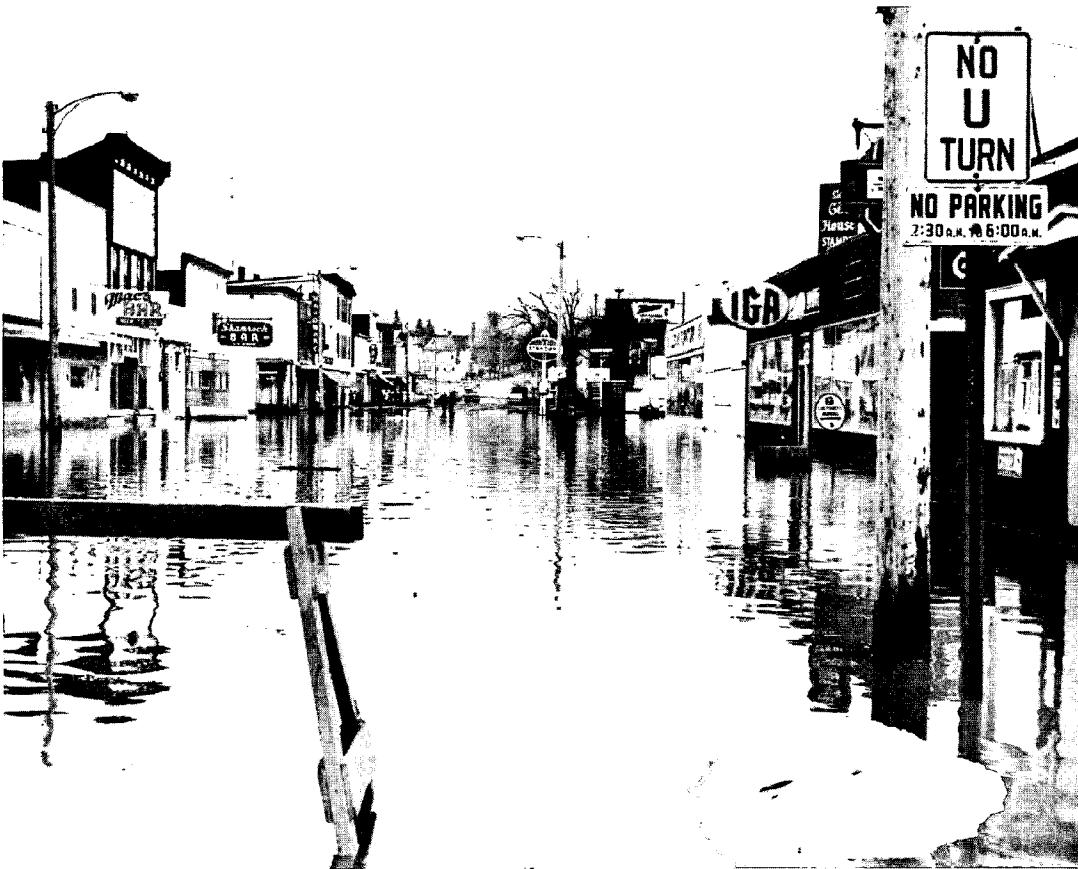
Figure 8. -- FLOOD SCENES IN ONTONAGON - APRIL 1963

Top view is an aerial photograph looking south at the flooded Ontonagon River. Note the massive ice jam at State Highway 64 near the center of the photograph. Lower view is looking south-east along River Street in Ontonagon.

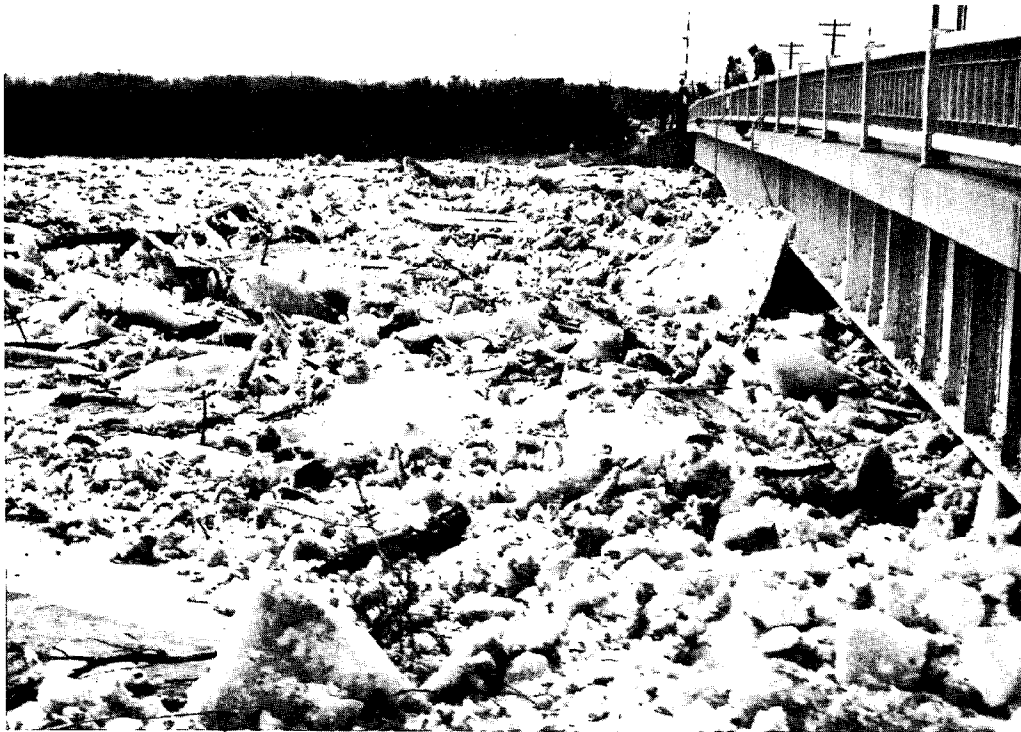
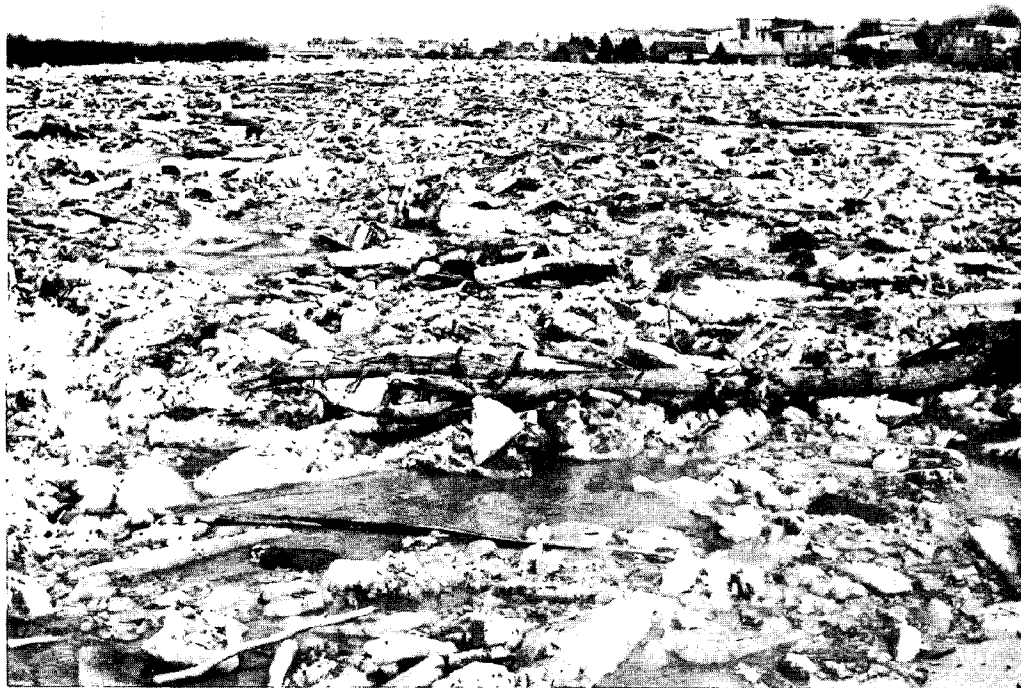
Figure 9. -- FLOOD SCENES IN ONTONAGON - APRIL 1963

These photographs show the intensity of the ice jam upstream from State Highway 64 during the April 1963 flood.

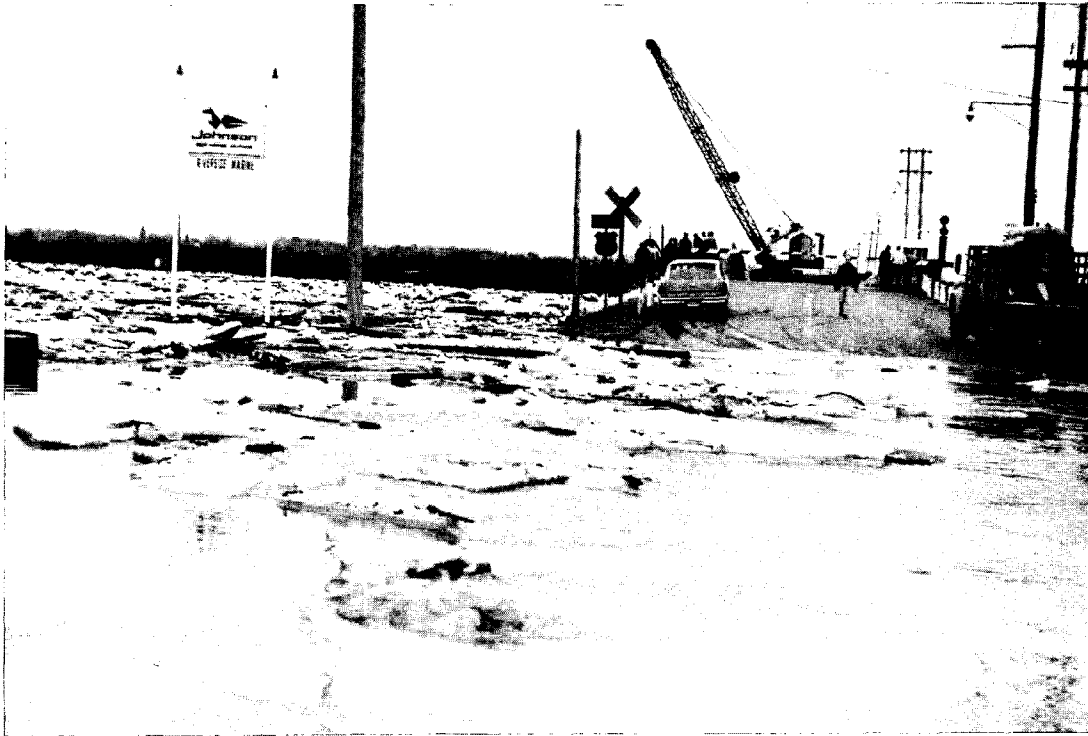
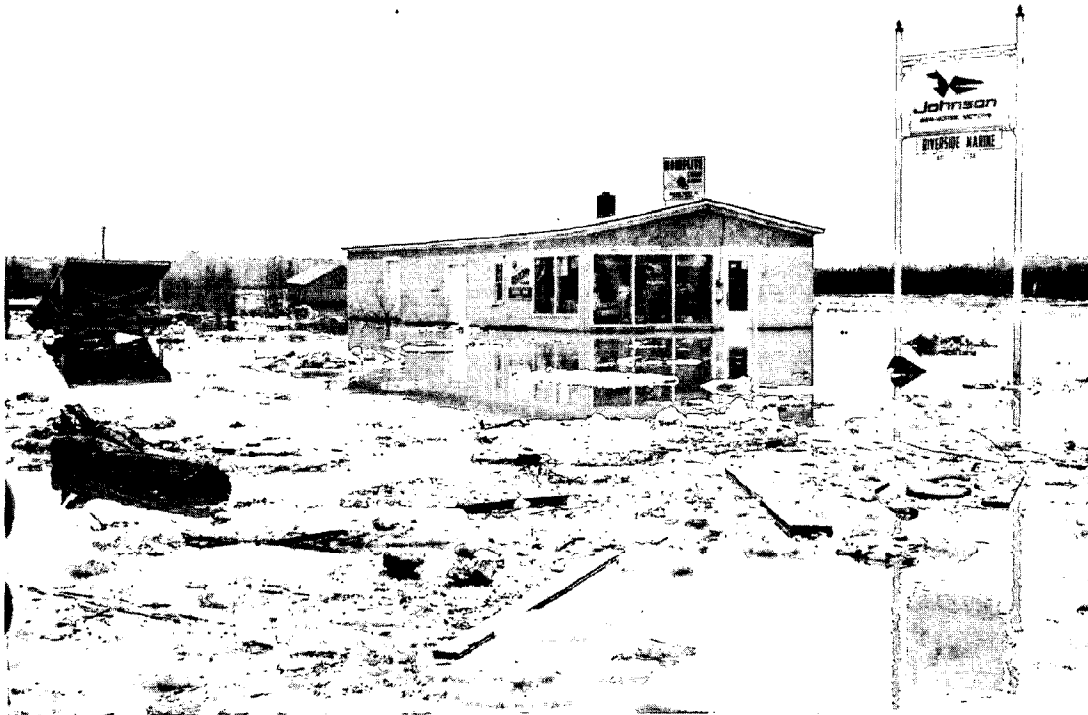
Figure 10. -- FLOOD SCENES IN ONTONAGON - APRIL 1963

These photographs show the extent of the 1963 flood at Riverside Marine near the east end of the State Highway 64 Bridge.

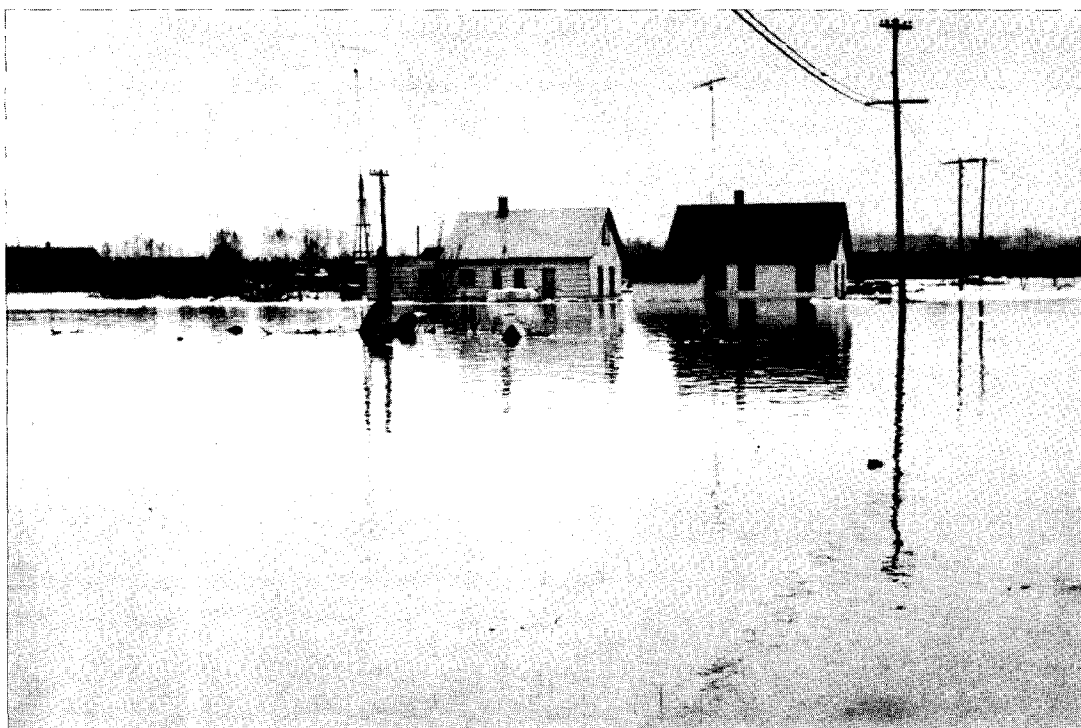
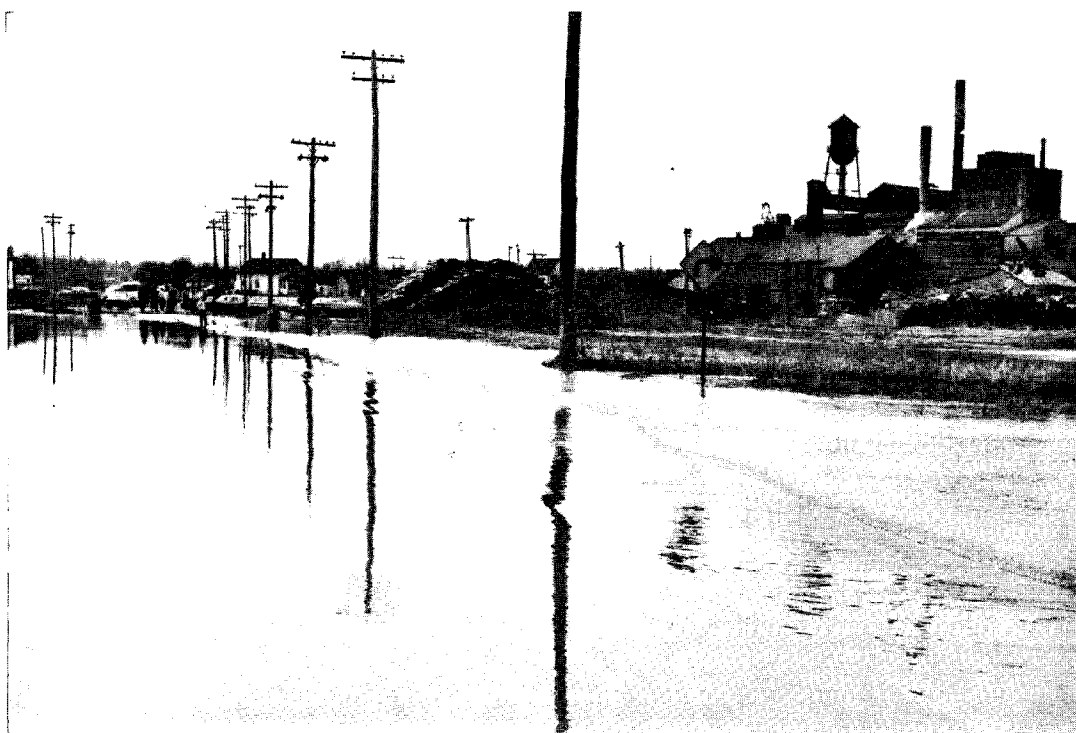
Figure 11. -- FLOOD SCENES IN ONTONAGON - APRIL 1963

Upper view shows flood conditions at the residences of Spencer Ross and Keith Roehm on the "island." Lower view was taken from State Highway 64 looking toward the Hoerner Waldorf Paper Mill on the west side of the Ontonagon River.

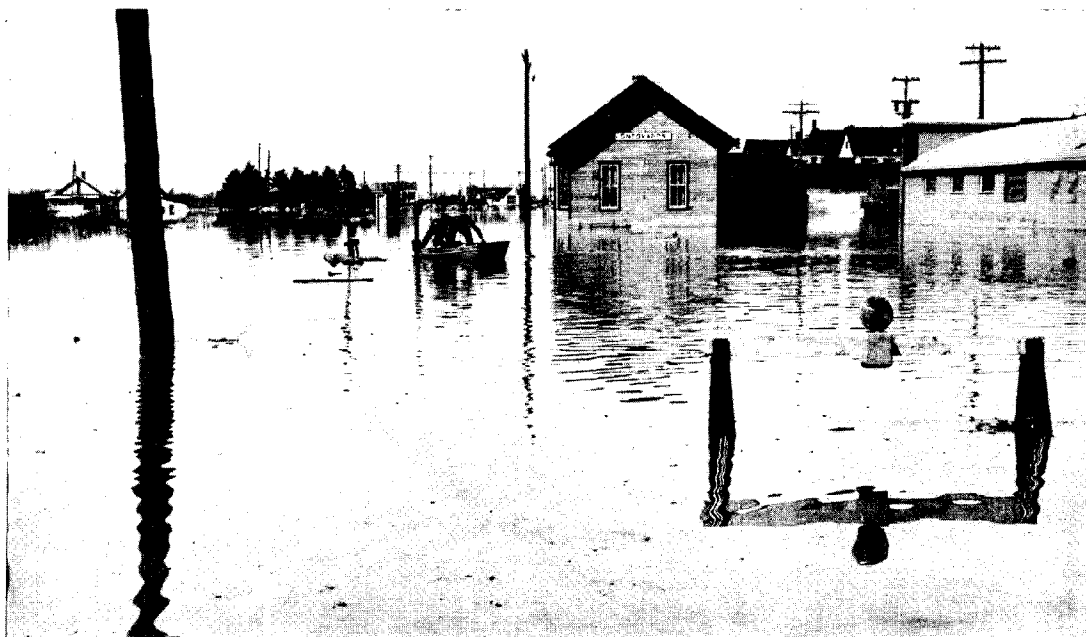
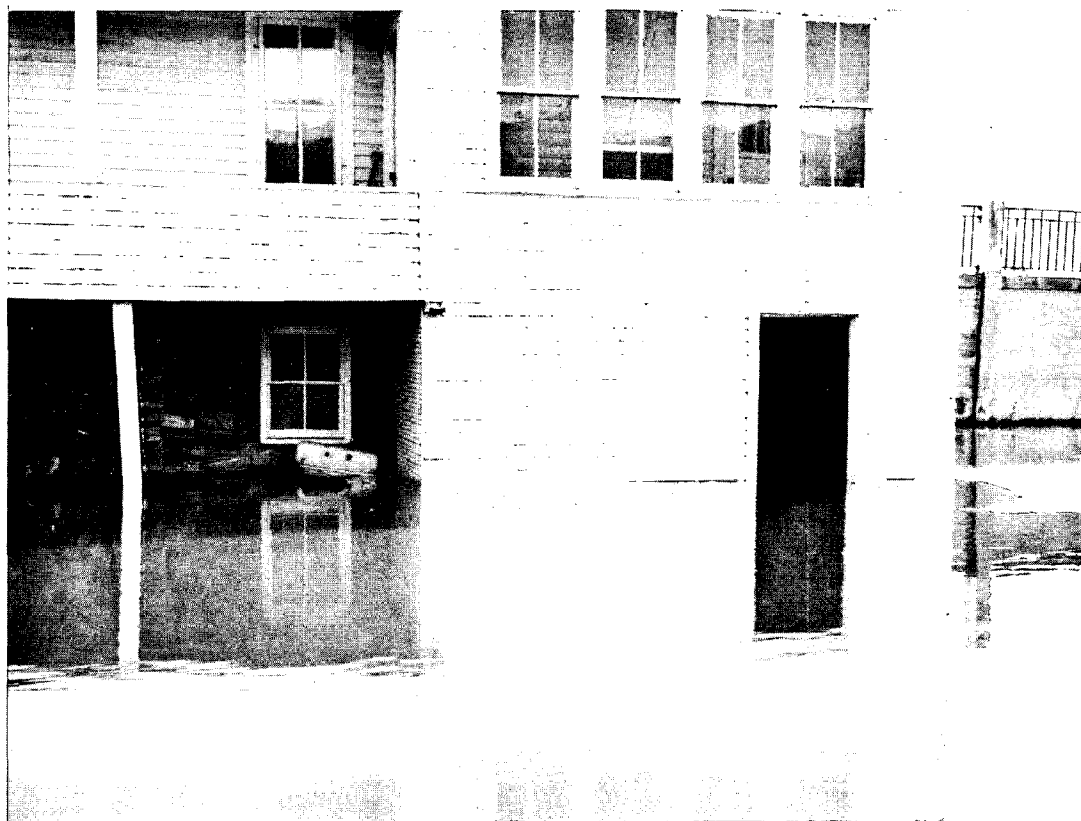
Figure 12. -- FLOOD SCENES IN ONTONAGON - APRIL 1963

Upper view shows flooded conditions around the Ontonagon Railroad Depot. Lower view indicates flooding at a residence in Ontonagon.

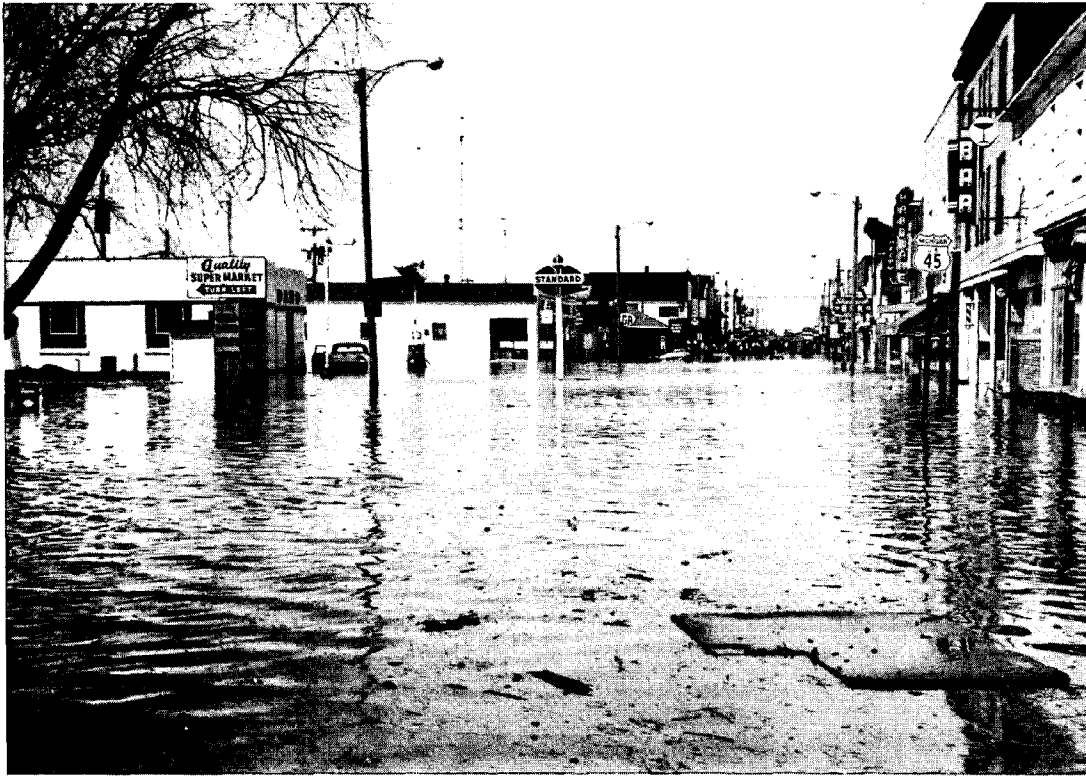
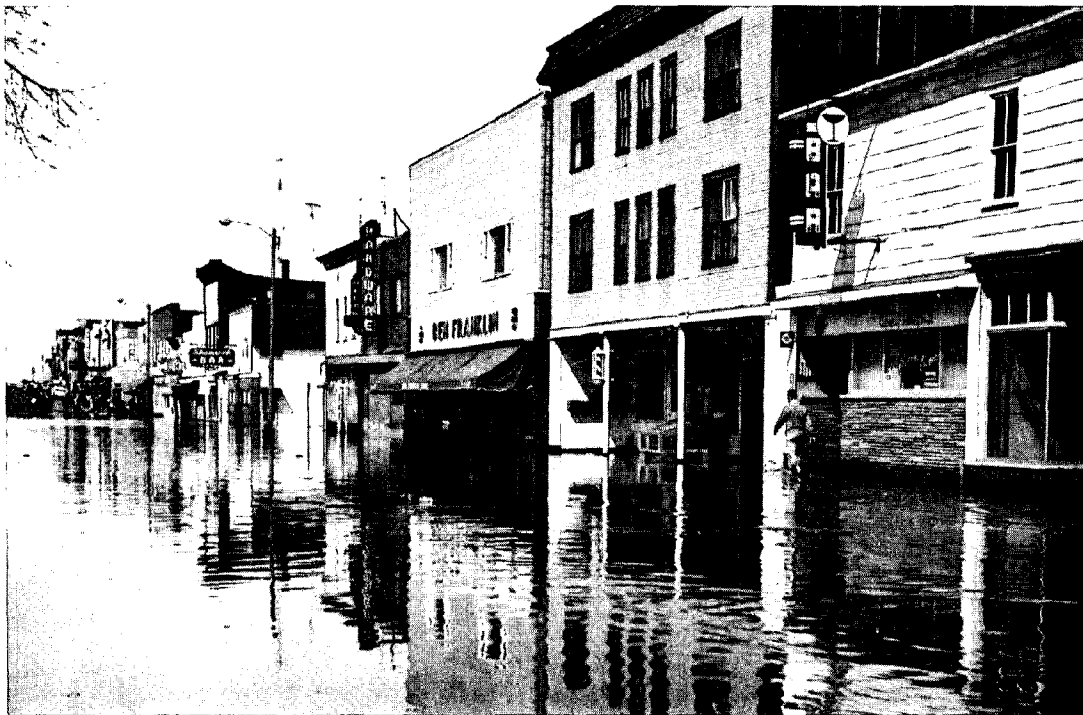
Figure 13. -- FLOOD SCENES IN ONTONAGON - APRIL 1963

These photographs were taken on April 1, 1963, looking northwest along River Street in Ontonagon.

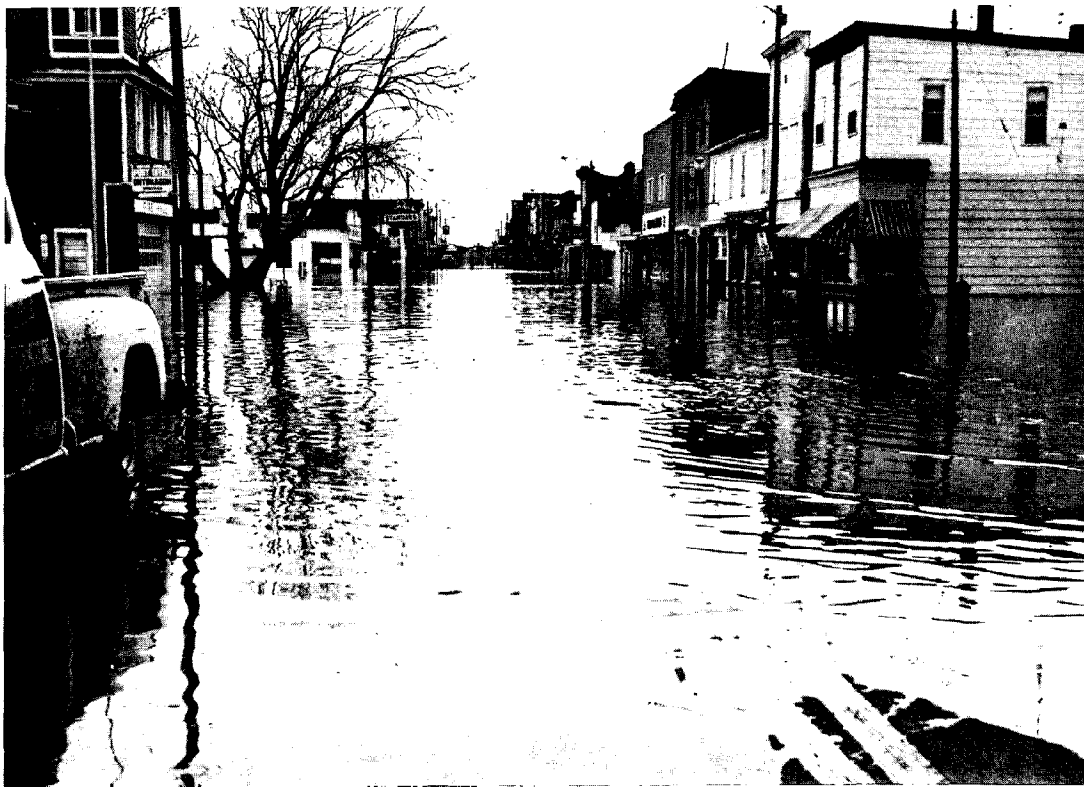
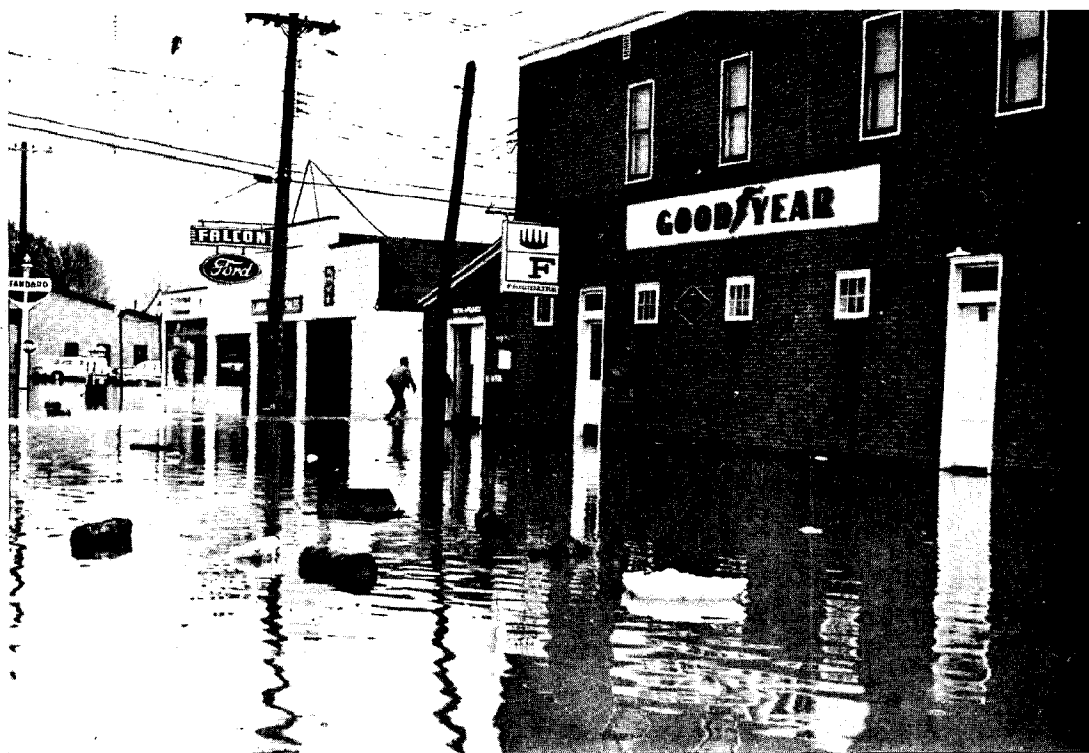
Figure 14. -- FLOOD SCENES IN ONTONAGON - APRIL 1963

Top view is looking northwest along the flooded River Street in Ontonagon. Lower view also shown flooded condition in the commercial area of Ontonagon.

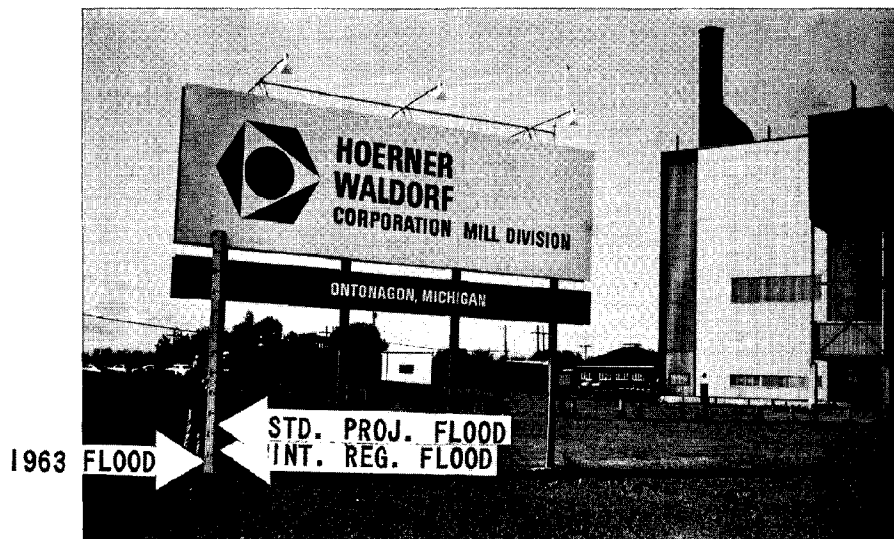
Figure 15. -- FLOOD HEIGHTS AT HOERNER WALDORF PAPER MILL

During the April 1963 flood the Hoerner Waldorf Mill was forced to shut down because of damage caused by flood waters on the Ontonagon River. Higher levels may be expected during the Standard Project and Intermediate Regional Floods as shown on the photographs.

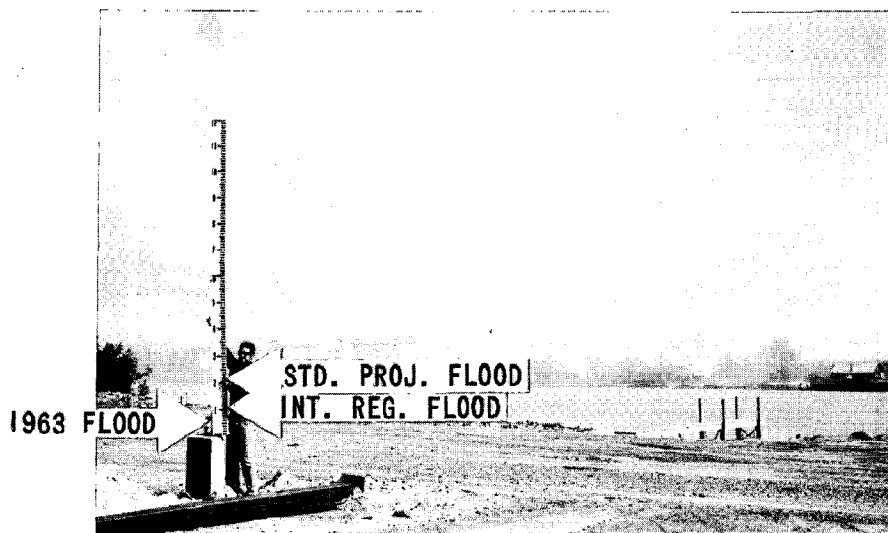
Figure 16. -- FLOOD HEIGHTS AT NEW MARINA

High water levels which may be expected during the Standard Project and Intermediate Regional Floods at the new marina which is under construction along the west bank of the Ontonagon River are shown above.

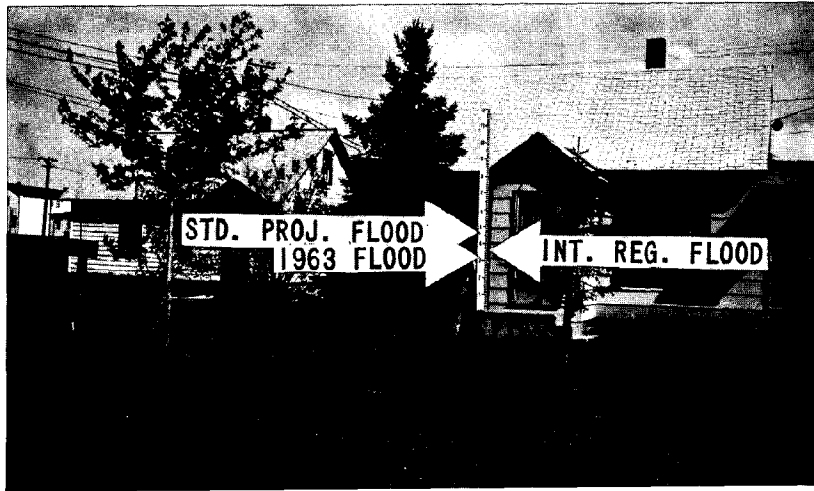
Figure 17. -- FLOOD HEIGHTS ALONG EAST SIDE SLOUGH

This residential area located near the east side slough was flooded to the depth shown on the photograph in April 1963. Future floods are expected to go even higher as shown by the Standard Project Flood and Intermediate Regional Flood arrows.

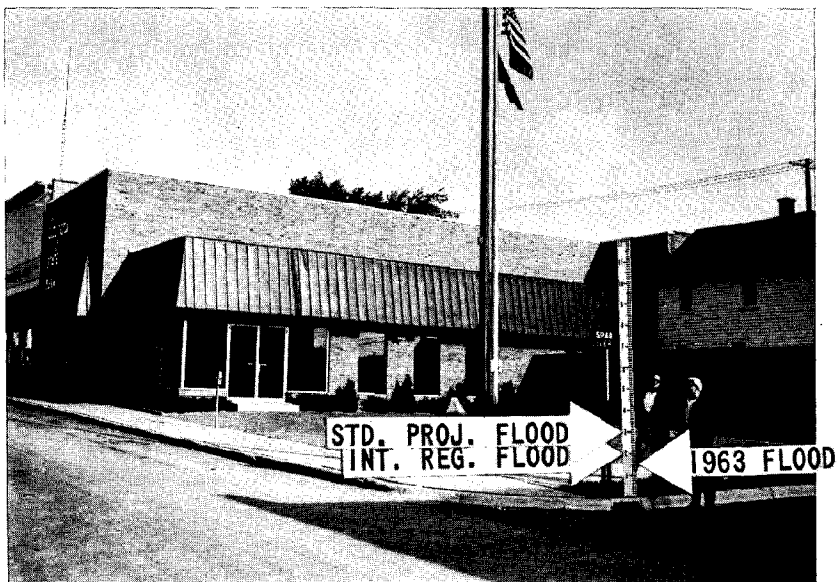
Figure 19. -- FLOOD HEIGHTS AT CITIZENS STATE BANK

Projected future flood levels and the level experienced during the 1963 flood are shown on this photograph which was taken at the corner of River and Spar Streets in Ontonagon.

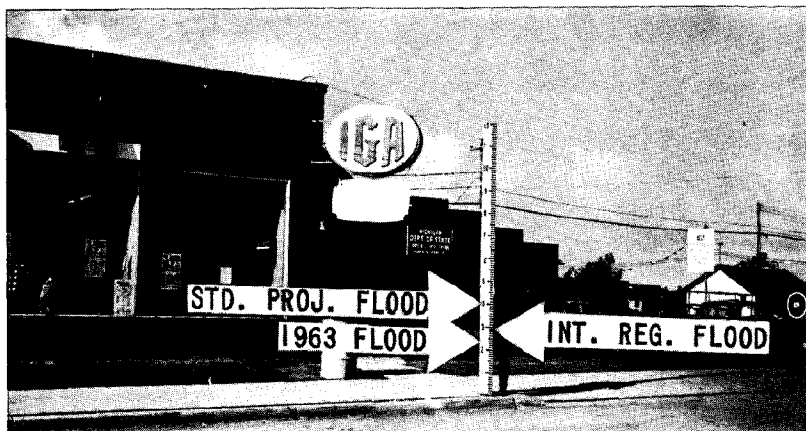
Figure 20. -- FLOOD HEIGHTS AT IGA FOODLINER

Merchandise in the store was extensively damaged when flood waters reached the level shown by the 1963 arrow. Even greater flooding would occur during an Intermediate Regional or Standard Project Flood.

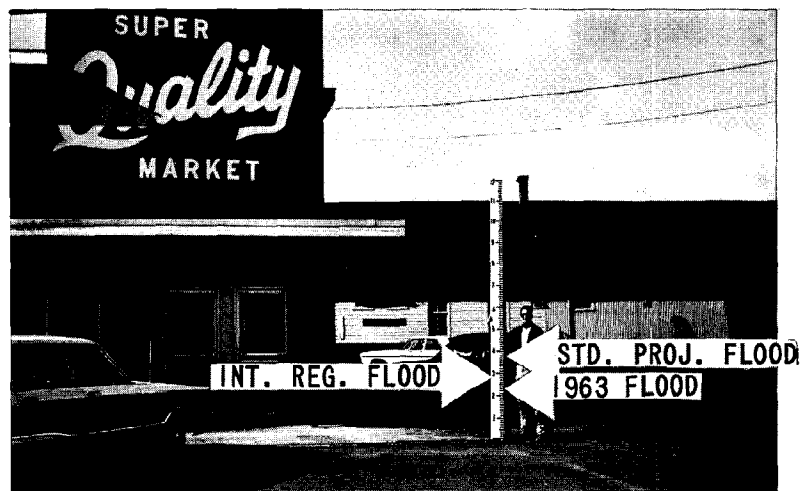
Figure 22. -- FLOOD HEIGHTS AT QUALITY SUPER MARKET

In April 1963 food stock within this store was damaged extensively. The level reached by the 1963 flood and levels which may be expected during an Intermediate Regional Flood and a Standard Project Flood are shown on the staff gage photograph.

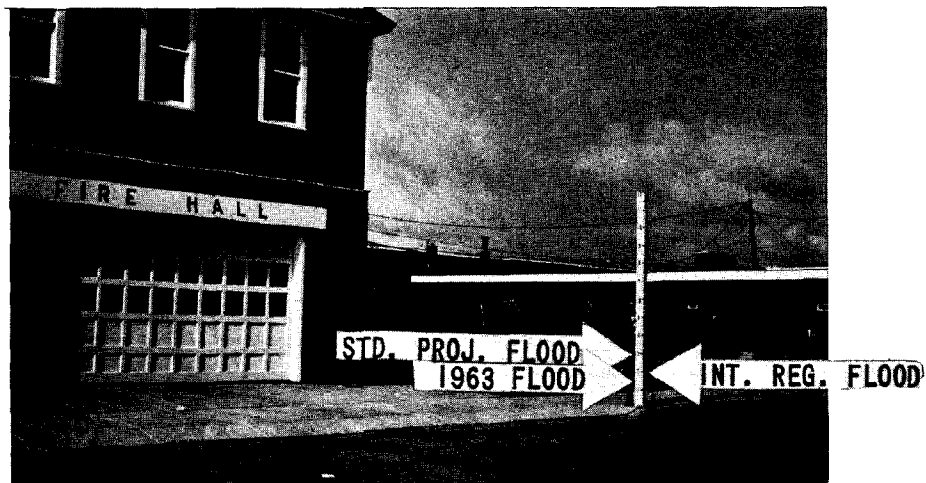
Figure 24. -- FLOOD HEIGHTS AT THE FIRE HALL

Flooding which extended for several blocks on River Street in 1963 was also evident at this location at the Ontonagon Village Fire Hall. Even greater depths, 2.0 feet for the Intermediate Regional Flood and 3.0 feet for the Standard Project Flood, may be anticipated.

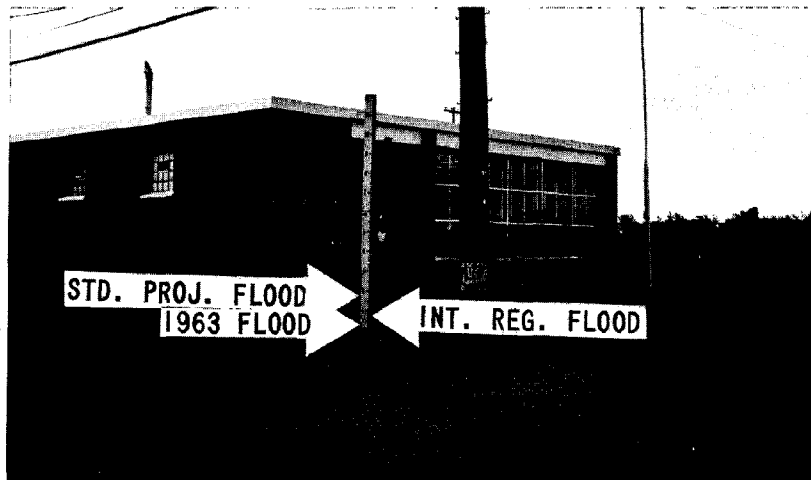
Figure 25. -- FLOOD HEIGHTS AT U. S. POST OFFICE

Although this building was not damaged by the 1963 flood it is vulnerable to the design floods of the future as shown on this photograph.

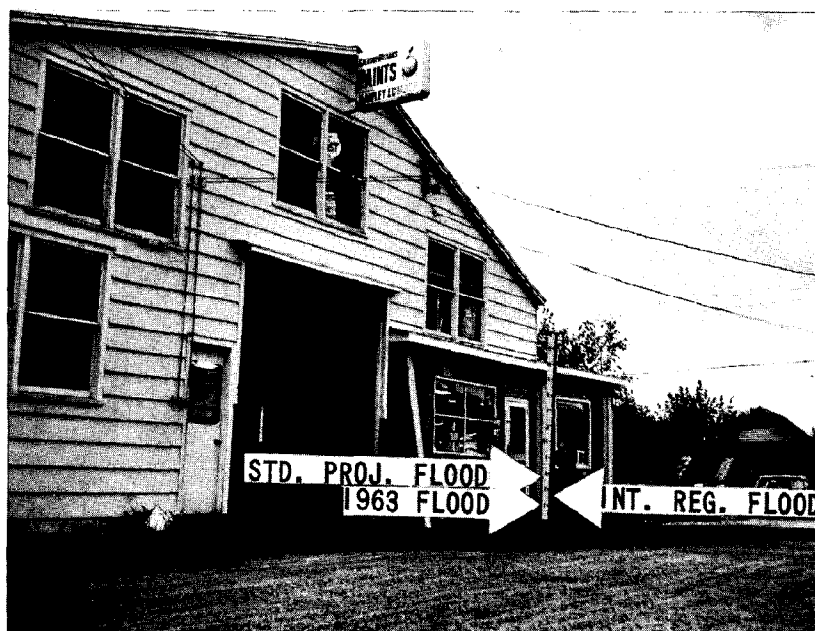
Figure 26. -- FLOOD HEIGHTS AT HAWLEY LUMBER YARD

This building located on Iron Street in Ontonagon was subject to the 1963 flood and may expect even higher levels during the Intermediate Regional and Standard Project Floods. The projected flood crests are shown above.

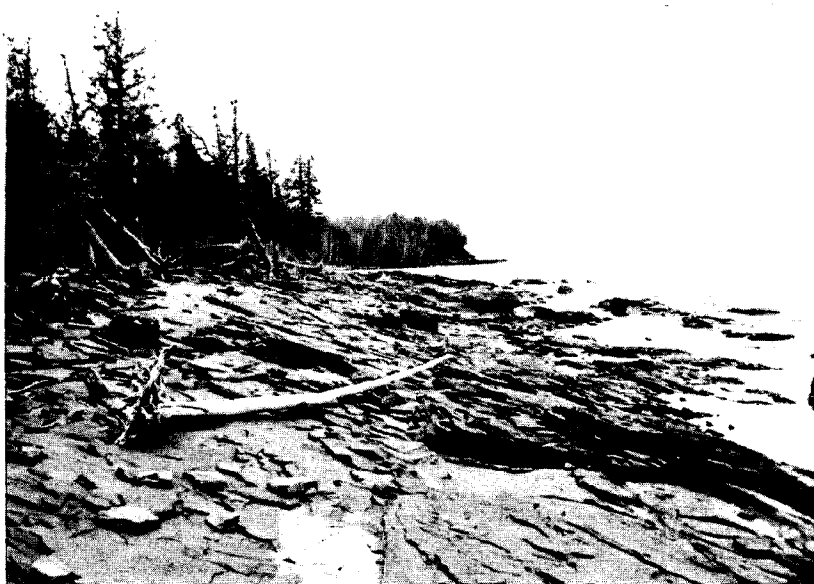
Figure 27. -- TYPICAL SHORELINE - REACH NO. 1

Reach No. 1. This reach begins at the westerly end of the study area and comprises the first 11,000 feet of shoreline. Along this reach, the shoreline follows a wave cut cliff in erosion resistant red sandstone with no sand beach. A typical view of Reach No. 1 is shown on Figure 27.

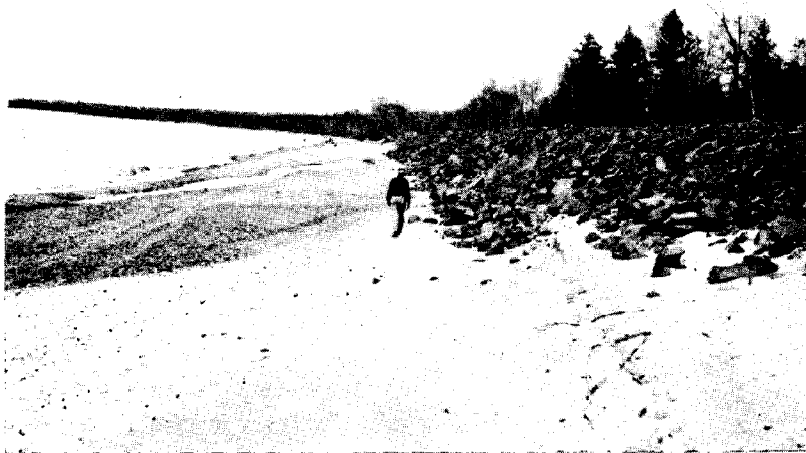
Figure 28. -- HIGHWAY PROTECTION - REACH NO. 2

Reach No. 2. State Highway 107 parallels the shoreline in the vicinity of Union Bay and is threatened by erosion. At one section in the middle of this reach, the recession of 1968 necessitated placement of about 1,000 feet of random stone seawall protection as shown on Figure 28. Similar protection has been required at several locations east of the Union River.
